# Manhole Inspection Summary

Manhole # S55C\_\_019MH

**Location** Address: **rear 3531 esther place** Cross Street: **n conkling aver**

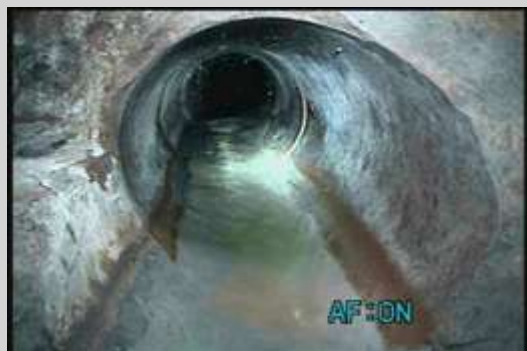
8 O'Clock Inflow

8 in. Circular Gravity Sewer  
Pipe In @ 8 O'Clock

Pipe Material: **Clay** ☐ Pipe Lined

Infiltration: **None** Pipe Seal Cond: **Unknown**
